Energy in cultural heritage: the case study of Monasterio de Santa Maria de Monfero in Galicia

### ENERGY IN CULTURAL HERITAGE: THE CASE STUDY OF MONASTERIO DE SANTA MARIA DE MONFERO IN GALICIA

**KEYWORDS:** historical building retrofit; internal wall insulation; heat and moisture simulations; cultural heritage; indoor thermal comfort;

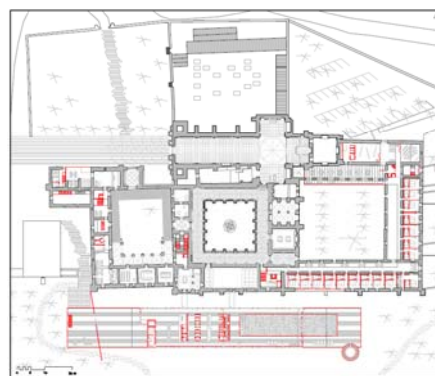
Fig.2 Hotel Spa proposal project - Ground Floor plan

On July 2004 the “Consellería de Cultura, Comunicación Social e Turismo” announced the contest of ideas for the rehabilitation of the monastery in hotel-spa. Enrique Blanco and Patricia Sabín Diaz were the winner of the first prize. Among others, competitors were Labics from Rome, Francisco Mangado from Navarra or Estudio Cano Lasso from Madrid [13]. The main ideas of the designers was to maintain the original aesthetics of the Monastery, without altering the perception and feeling that the building provided to the visitors. The first actions were cleaning and securing the unstable parts of the building. The project provide minimum interventions respecting as much as possible the existing masonry: new holes for the windows and doors were open only where essential, covering were provided where missing.

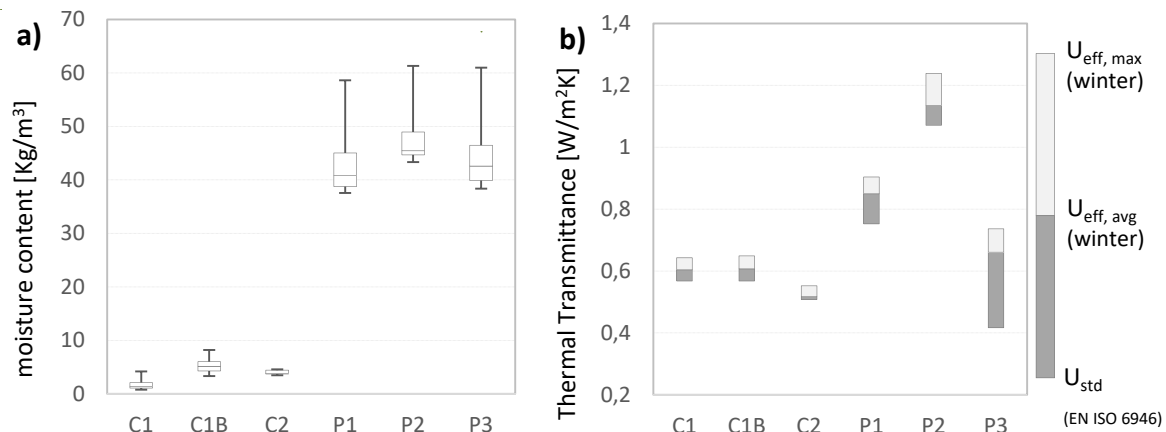
Fig.3a shows the moisture content  $mc$  ( $\text{kg/m}^3$ ) of the insulating layers: mineral wool and PUR (counter wall) and thermal plasters. Simulations were performed for 3 years, but the results refer to the last year of simulations since it is not influenced by the initial conditions. The box-plots summarise all the hourly moisture content results, and the maximum and minimum value are indicated for all the design

alternatives. The bottom and top of the box represent the first and the third quartile, and the band inside the box is the median of the data (second quartile).

Fig.3 a) Box-plot analysis: moisture content in the insulation layer  $mc$  [kg/m<sup>3</sup>],  
b) Wall thermal transmittance  $U$  [W/m<sup>2</sup>K] calculated for winter period (October – April)

The results shows higher water content on the thermal plaster configuration due to the higher capability of plasters to absorb and store moisture if compared to mineral wool and PUR. The results show  $mc$  values of plaster (P1, P2, P3) from 5 to 10 times higher if compared to the counter wall configuration. The data concerning the thermo-hygrometric behaviour of the various solutions allow to make further discussion on the use of vapour barriers. The result reveals that in C1 the addition of a vapour barrier (C1<sub>B</sub>) between the gypsum board and the mineral wool layer determine an increase of the moisture content. Although the current practice suggests to add the vapour barrier on the warm side of the insulation, in this particular case (unprotected external walls exposed to driving rain) the presence of water vapour does not allow the re-evaporation of moisture on the interior side resulting in a non-negligible moisture storage inside the insulation layer. For this specific case the result is not effective and should be avoided, the values of  $mc$  for C1 reach a maximum of about 4 kg/m<sup>3</sup> compared to 8 kg/m<sup>3</sup> with a vapour barrier (C1<sub>B</sub>).

The variation of the thermal transmittance (first-third quartile and median value) during the winter period are illustrated in Fig.3b. Results demonstrate how much the environmental conditions affect the performance of the insulation layer, even if it is placed on the inner side. Indeed an important factor that affects the thermal performance is represented by the water content in the insulating layer.

A clear difference between the value of  $U_{std}$  (thermal transmittance) calculated according to EN ISO 6946:2007 (considering dry materials) and the  $U_{eff}$  calculated taking into account the moisture dependency of the thermal conductivity was observed, in particular:

- A higher difference between  $U_{std}$  and  $U_{eff, avg}$  was observed in plasters due to the presence of high moisture content;
- All the retrofit configurations show a reduction of the  $U_{std}$  from the initial value of the bare wall ( $\sim 2.8$  W/m<sup>2</sup>K), between 62% (P2) and 83% (P3);

- Counter wall configurations presents lower  $U_{eff,avg}$  (between 0.52 and 0.61 W/m<sup>2</sup>K). Nevertheless, plaster P3 (aerogel based) shows slighter higher  $U_{eff,avg}$  results, even though in line with the counter wall systems (0.66 W/m<sup>2</sup>K).

As the bar graph shows, always result in  $U_{eff,max} > U_{dry}$ , due to the presence of moisture on the configuration. In general, it appears how this phenomenon is more impacting on thermal plaster than on the counter wall. Actually the  $U_{eff,avg}$  value for the plaster configurations results almost 17% higher than  $U_{std}$ , while the  $U_{eff,avg}$  value of the counter wall grow from 12% to 33%.
